Important Consumer Dehumidifier Service Repair Information

The Problem...

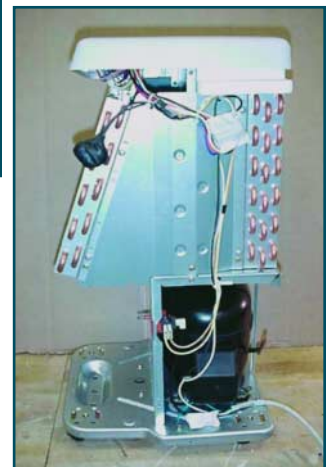
Once the service technician checked all of your units connections, the wire harness, bucket switch, de-icer and control panel assemblies were replaced.

Replacement parts are designed to ensure the safe and normal operation of your dehumidifier.

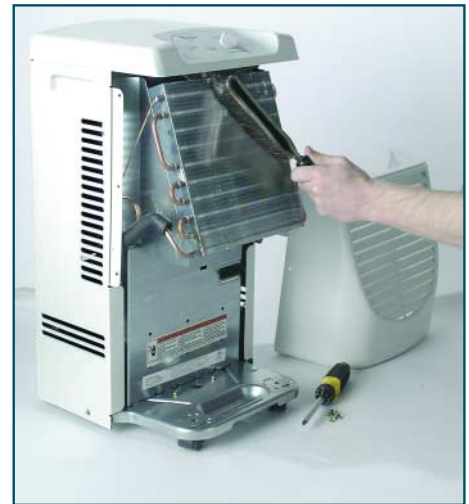
The technician also cleaned your unit by removing all dust and rinsing the water bucket.

Lastly, a black circle was added next to the serial number tag. This black circle signals that your dehumidifier has been repaired and is safe to use.
