# Important Consumer Dehumidifier Service Repair Information

## The Problem...

## The Solution...

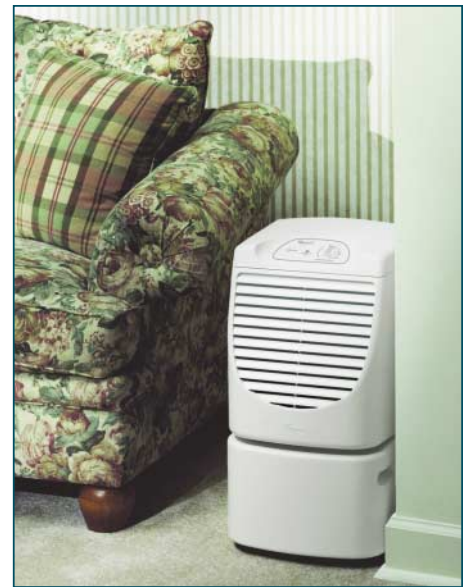
In some Whirlpool-built dehumidifiers, certain internal components including wire terminals and switches can overheat. This can result in fire and cause personal injury or property damage.

Whirlpool, working in close cooperation with the Consumer Product Safety Commission, has voluntarily recalled its dehumidifiers to repair this problem.

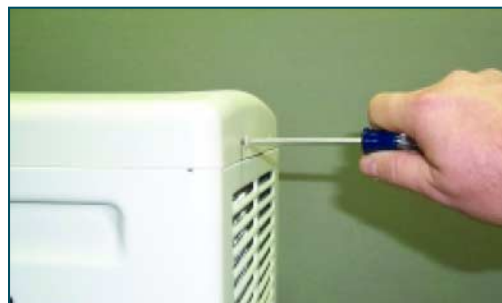
The cabinet was removed to expose the control panel and internal components inside the dehumidifier.
